| Drive European 30-A Hillwood Ave. Falls Church, VA 22046 PH: 703.536.4500 FX: 703.536.4789 www.DriveEuropean.com | INSPECTION REPORT DATE: 06/13/2018 Drive European Inspection 02 PAGE: 1 PERFORMED BY: |
| CUSTOMER: JOHN SMITH ADDRESS: 123 ELECTRIC AVE. CITY: FALLS CHURCH, VA 22046 PHONE1: PHONE2: | VEHICLE: 2016 AUDI LICENSE: V12345678 VIN: VHGM2456849 ENGINE: Cyl L5 Disp 2.5 MILEAGE: 41519 COLOR: |

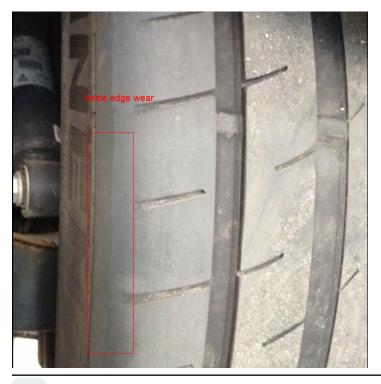
15. Tire Measurement- % (continued)

| Drive European 30-A Hillwood Ave. Falls Church, VA 22046 PH: 703.536.4500 FX: 703.536.4789 www.DriveEuropean.com | INSPECTION REPORT DATE: 06/13/2018 Drive European Inspection 02 PAGE: 1 PERFORMED BY: |
|--|--|
| 15. Tire Measurement- % | LABOR: Replace 2 tires-rear tires are worn to the markers and unevenly. fronts are OK. PARTS: |

| Drive European 30-A Hillwood Ave. Falls Church, VA 22046 PH: 703.536.4500 FX: 703.536.4789 www.DriveEuropean.com | INSPECTION REPORT 000020603 DATE: 06/13/2018 Drive European Inspection 02 PAGE: 4 PERFORMED BY: | | | |
|--|--|--|--|--|
| 32. Alignment | Due to uneven tire wear. | | | |

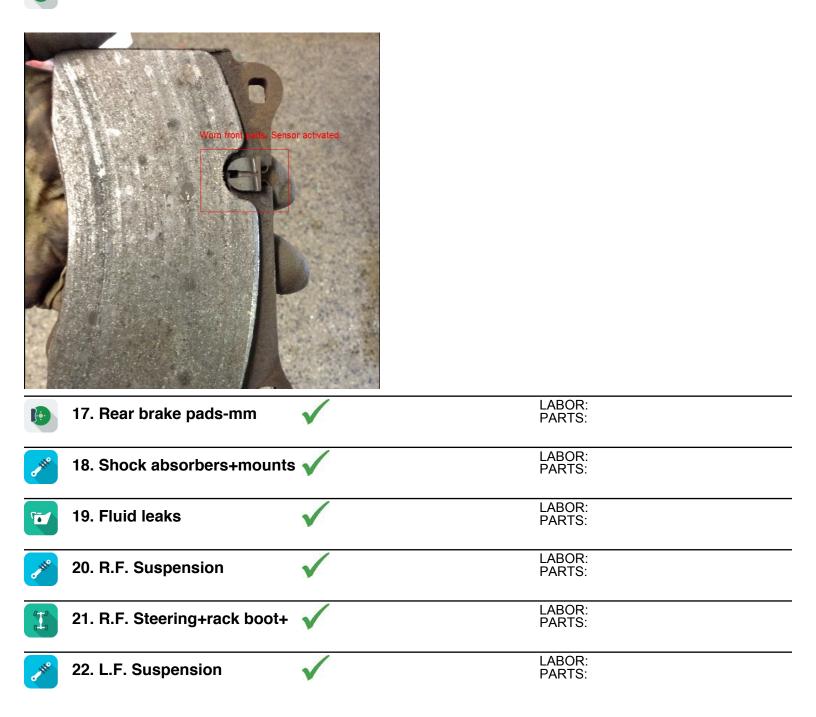
16. Front brake pads-mm (continued)

16. Front brake pads-mm

LABOR: Replace front pads and rotors-Worn PARTS:Pads+Rotors+Sensor
